2012:
 Based on around 8,000 cracks detected in the area of the crane systems, ArcelorMittal Gent and the Belgian welding institute BIL were looking for an effective method for sustainable repair or for preventing fatigue cracks. Through an R&D project in their own OCAS institute, they recognized PIT as the most promising solution.

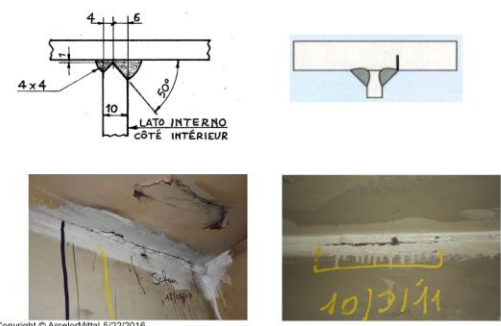
Examples of fatigue in cranes

2014:
 ArcelorMittel trained them employees and introduced PIT. From this time, crack-free hot spots were treated preventively, as well as repair welds were PIT treated.
